TECHNICAL REPORT ARCCB-TR-97007

FATIGUE ANALYSIS OF A VESSEL EXPERIENCING PRESSURE OSCILLATIONS

EDWARD TROIANO JOHN H. UNDERWOOD ANTHONY SCALISE G. PETER O'HARA DANIEL CRAYON

MARCH 1997

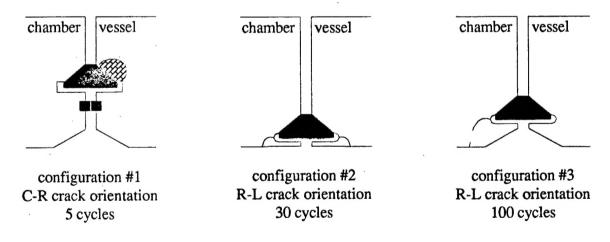
Figure 2. Historical perspective of seal configurations.

The detailed sealing concepts investigated in this study are described in Figure 2. The original sealing concept (configuration #1) included a two-surface wedge seal encased in a rectangular shaped seal pocket at the radial wall location, r/c, of 0.68. Configuration #1 also included a guard ring located at the radial wall location of 0.62. The guard ring possessed four through holes located at 0°, 90°, 180°, and 270° from the top center

position of the pressure vessel. The guard ring provides a barrier between the internal combustion by-products and the seal. The through holes in the guard ring allow pressure to enter the seal pocket and force the two seal surfaces against their mating surfaces on the chamber and vessel, respectively. Cracking in the vessel portion of configuration #1 was observed after only five loading cycles. Cracking initiated at a mid-wall location

emanating from the rectangular seal pocket in the C-R orientation (a plane perpendicular to the circumferential direction, with crack growth predominately in the radial direction). At the time of the failure very little was known about the nature of the pressure oscillations. The cracking was in an area of known tensile stresses, including applied hoop firing stresses and residual hoop autofrettage stresses. Although the combination of applied and residual stresses was well below the yield strength of the vessel material (see stress versus wall location plot in Figure 3), the sharp stress riser of the rectangular seal pocket may have concentrated the local stresses to about the level of the yield stress. At this time further investigation of configuration #1 was halted because the source of the stresses and the failure had been characterized well enough to proceed to configuration #2.

The configuration #2 concept used the lessons learned in configuration #1 to make significant improvements to the seal area. Major changes included moving the seal closer to the inside diameter of the vessel and chamber to a radial wall location of 0.55 and removing the rectangular seal pocket in lieu of a semicircular (r = 3.2 mm) seal pocket. As seen in the plot of Figure 3, the configuration #2 seal and seal pocket are at a location of nearly zero hoop stresses. The semicircular seal pocket reduced the local high stresses that resulted from the sharp stress concentrator, which may have contributed to the failure of configuration #1. Seal lips integral to both the chamber and vessel replaced the guard ring to protect the seal. Configuration #2 cracked after approximately 30 loading cycles.

Cracking initiated in the chamber and vessel at the root of the seal pocket notch, in the R-L orientation (a plane perpendicular to the radial direction, with crack growth predominately in the longitudinal direction). Both seal pockets had nearly identical cracks at the same radial location; these cracks eventually grew approximately 50 mm in length along the root of the seal pockets. During testing of configuration #2, the presence of pressure oscillations became evident. However, as with configuration #1, the full extent of the pressure oscillations was not understood.

Configuration #3 had the same seal and seal pocket as configuration #2. The main difference was that the location of the seal was now at a radial wall location of 0.62. Although clearly not in as favorable a hoop stress region, this wall location allowed designers the opportunity to provide a stiffer seal lip and the necessary protection for the seal itself. After 100 loading cycles, configuration #3 failed in a similar fashion to configuration #2. A radial stress-induced crack (R-L orientation) emanated from the root of the seal pocket on the chamber side and grew approximately 50 mm in length until a section of the seal lip became dislodged. Unlike the failure of configuration #1, the source of the radial stress that initiated the crack was not known, and proprietary concerns prevented any definitive investigation. An analysis of possible sources of radial stresses near the seal is given below. During testing of configuration #3, the full extent of the pressure oscillations became evident. The extent of these pressure oscillations will also be discussed below.

Figure 2 shows that each of these configurations failed in the R-L orientation as a result of a radial tensile stress. However, according to the results in Figure 3, the radial stresses in the area of the seal pocket were compressive. The analysis used for configuration #1 predicted infinite life for these configurations, which we know was not the case.

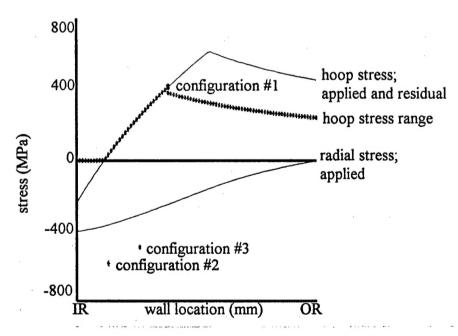
Figure 3. Theoretical stress distribution taking into effect Lamé stresses and autofrettage stresses; points indicate effects of K_r .

The total hoop stress (at maximum pressure) from equation (5), and the resultant tensile hoop stress range for configuration #1 is plotted in Figure 3. The configuration #1 point lies directly on the hoop stress profile because there is no stress concentrator in the hoop orientation; thus equation (5) does not require a K_i scaling factor.

Figure 3 shows the resultant radial stresses (at maximum pressure) for configurations #2 and #3—accounting for the previously described stress concentrators. In the next section, the maximum stress values (and stress ranges) from equations (5) and (9) are used to determine the local stress ranges at the failure locations.

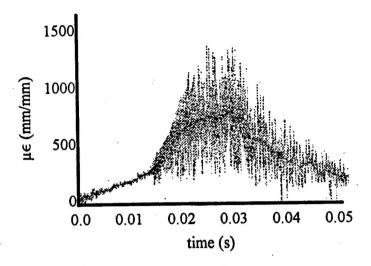
Figure 4. Typical strain versus time plot showing loading oscillations.

Typically, large caliber cannon pressure vessels, such as the one investigated here, experience a pressure versus time trace that is relatively smooth and of a sinusoidal waveform—rising from zero to peak pressure and back to zero in approximately 0.05 second. Oscillations are often observed during a normal loading cycle. However, the relative number and magnitude of these oscillations are typically very small. The vessel and chamber investigated here experienced a different, more complex loading history. A strain range-time plot (as measured by hoop strain gages placed on the outside diameter of the chamber) is shown in Figure 4. In this case, more than 1400 strain reversals were measured; however, in other cases as many as 2000 strain reversals have been recorded. One of the major concerns with this loading history is that the magnitudes of some of the strain reversals have exceeded the average nominal strain that is typically experienced. The data for configuration #1, depicted in Figure 4, were analyzed, and a histogram of the number of occurrences at each strain range and R-ratio was made. (These nominal strains were also used to calculate local strains for configurations #2 and #3.) The results are shown in Figure 5. Analysis of the histogram shows that 68 percent of occurrences are within the 0 to 5 percent of maximum strain range, and 90 percent of the occurrences occur between 0 and 15 percent of the maximum strain range.

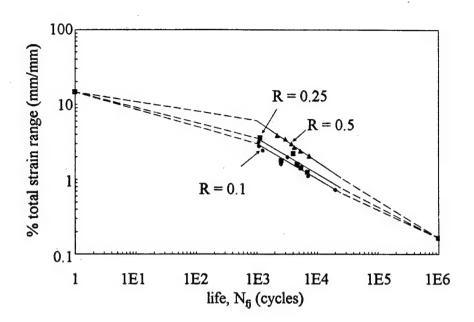
Figure 7. Low cycle fatigue data for A723 steel; $\sigma_{YS} = 1172$ Mpa, $K_t = 3.0$.

Because configuration #1 failed in the C-R orientation, and the hoop stresses in the seal pocket region (equation (5)) were known to be tensile, the use of equation (10) predicted that the A723 steel vessel should survive a total of $B_f = 9,400$ repetitions before failure. The PH 13-8Mo chamber, which possesses better fatigue resistance than the A723 steel, should survive $B_f = 16,200$ repetitions before failure. Both predictions are orders of magnitude higher than the five cycles-to-failure in the fielded system.

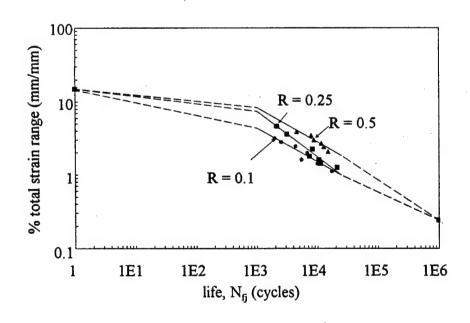
Figure 8. Low cycle fatigue data for PH 13-8Mo stainless steel; $\sigma_{YS} = 1276$ Mpa, $K_t = 3.0$.

The effects of the compressive residual stresses for R < 0 have not been properly analyzed in the laboratory. Although no attempt was made to model these desirable residual stresses, it is known that their omission in the analysis would lead to conservative results. ^[9] In the analysis, all of the N_j with $R \le 0.1$ were modeled in the laboratory at R = 0.1; those with $0.2 \le R \le 0.3$ were modeled in the laboratory at R = 0.25; and those with $R \ge 0.4$ were modeled at R = 0.5. The stresses predicted by equations (5) and (9) are in the elastic region. Therefore, Hooke's law ($\epsilon = \sigma/E$) was utilized to convert these seal pocket stresses into seal pocket strains. Once the conversion was made, the data in Figures 7 and 8 allowed N_f to be calculated. At this point, B_f for each material and configuration could be determined.
